**Flood Control Project Maintenance
Levee Inspections****LMA District Cover Sheet****Spring 2013 Levee Inspection Results****Sutter Maintenance Yard Nelson Bend**

Spring 2013 Levee Inspection Results

Sutter Maintenance Yard Nelson Bend

Waterway			Bank	Unit Miles
Unit No. 01 Feather River West Levee-Nelson Bend				0.50
	Spring (March - May)	Summer (June - August)	(September - November) Fall	Winter (December - February)
Unit Maintenance Rating (Fall Only)				
Date of Inspection	05/10/2013 - 05/10/2013			
DWR Inspector	Bob Duffey			
Accompanied By

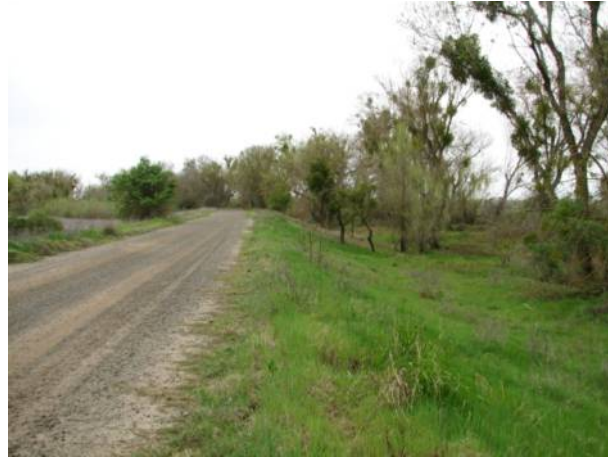
Levee Mile Report Line	2
Start Levee Mile	0.01
End Levee Mile	0.45
Location	Land Side
Category	
Item	Vegetation
This photo was taken at levee mile 0.00 looking downstream at the landside vegetation.	
rduffey_s_20130509_390.JPG

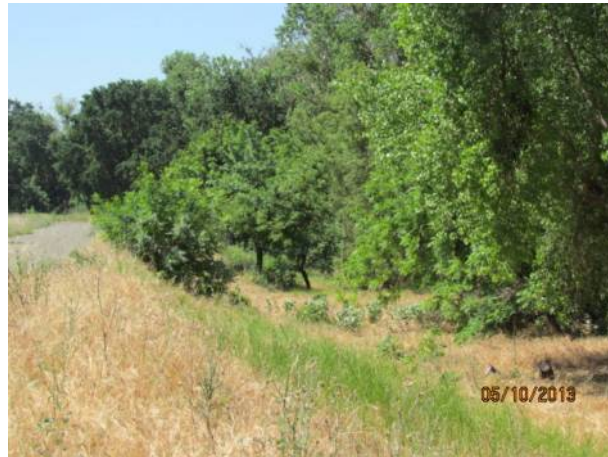
Levee Mile Report Line	3
Start Levee Mile	0.01
End Levee Mile	0.45
Location	Land Side
Category	
Item	Trim / Thin Trees
Trim the trees up 5 feet to allow visibility.	
rduffey_s_20130513_391.JPG

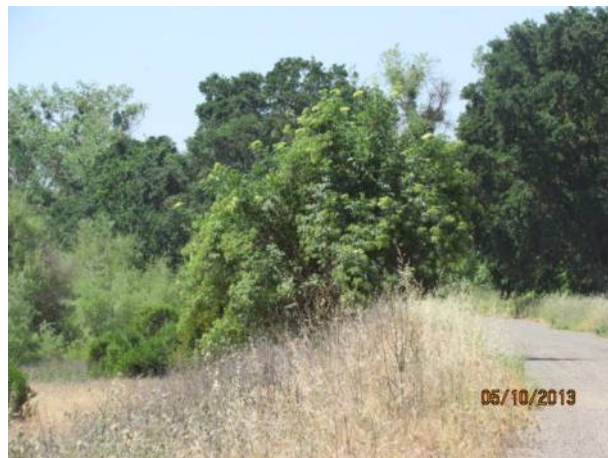
4	0.05	0.05	Vegetation	WS M Ma	V4 : Elderberries are blocking visibility and flood fight capability.	38.886408 ° -121.615092 °	38.886408 ° -121.615092 °	4 Y	
DWR ID: DWR_ST0006_01_s_2012_4									
5	0.13	0.22	Vegetation	WS M Ma	V4 : Elderberries are blocking visibility and flood fight capability.	38.885320 ° -121.615677 °	38.883970 ° -121.615830 °	5	
DWR ID: DWR_ST0006_01_s_2012_5									
6	0.30	0.30	Vegetation	WS M Ma	V4 : Elderberries are blocking visibility and flood fight capability.	38.882870 ° -121.615477 °	38.882870 ° -121.615477 °	6	
DWR ID: DWR_ST0006_01_s_2012_6									
7	0.48	0.48	Encroachments	CR U En	BU : Building	38.880488 ° -121.614230 °	38.880488 ° -121.614230 °	8	
DWR ID: DWR_ST0006_01_s_2012_8

Levee Mile Report Line	4
Start Levee Mile	0.05
End Levee Mile	0.05
Location	Water Side
Category	
Item	Vegetation
View of the elderberries that are blocking visibility.	
rduffey_s_20130513_392.JPG
